Manhole Inspection Summary

Manhole # S29AA2018MH

Insp Date: **9/30/08 3:27 PM**

Location Address: **5 TAMWORTH RD**

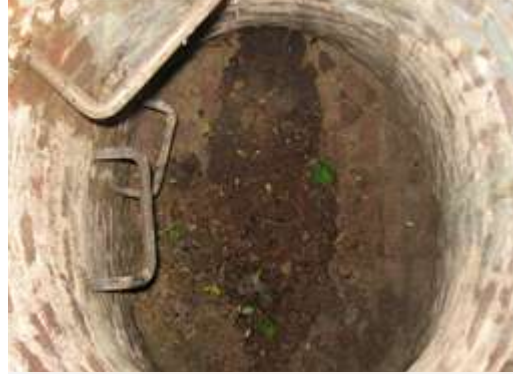
Top View

Channel debris.

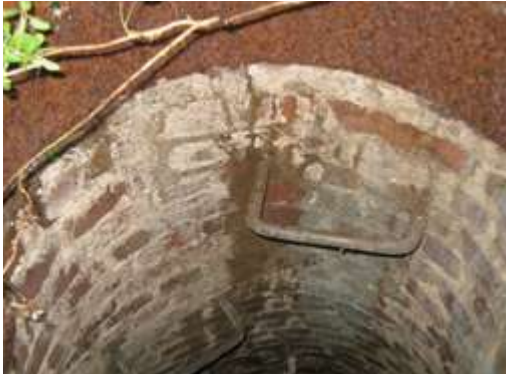
Defect

Adjustment and Corbel infiltration.

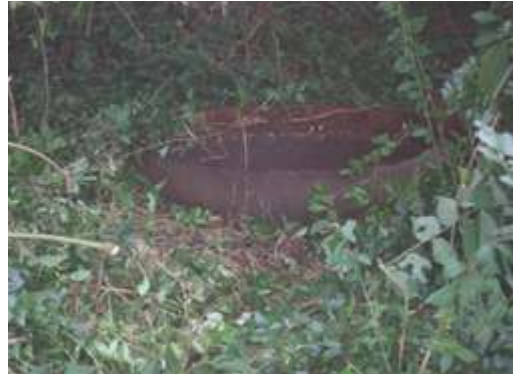
Defect

Above grade.

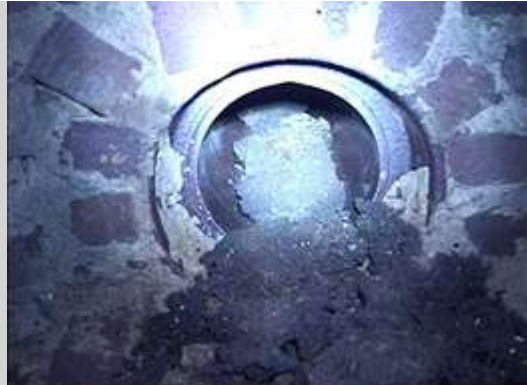
8 in. Circular Gravity Sewer Pipe Out @ 12 O'Clock

Infiltration: **Evidence** Pipe Seal Cond: **Unknown**

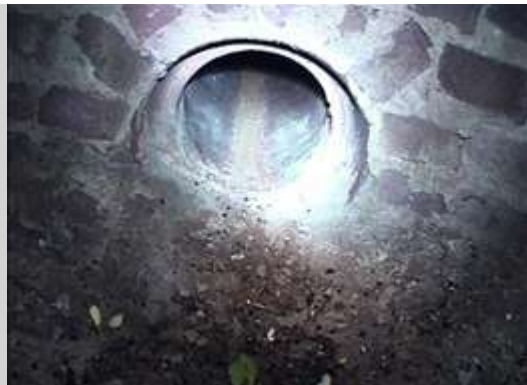
8 in. Circular Gravity Sewer Pipe Out @ 6 O'Clock

Infiltration: **Evidence** Pipe Seal Cond: **Unknown**
